EVALUATION OF WATER RESOURCES IN BOLIVIA, SOUTH AMERICA

DECEMBER 1990

4. TITLE (and Subtitle) Evaluation of Water Resources in Bolivia, South America		5. TYPE OF REPORT & PERIOD COVERED Technical Assistance Nation to Nation December 1990

9. PERFORMING ORGANIZATION NAME AND ADDRESS U.S. Army Engineer District, Mobile Military Planning Branch Planning Division (CESAM-PD-M) P.O. Box 2288, Mobile, AL 36628-0001		10. PROGRAM ELEMENT, PROJECT, TASK AREA & WORK UNIT NUMBERS

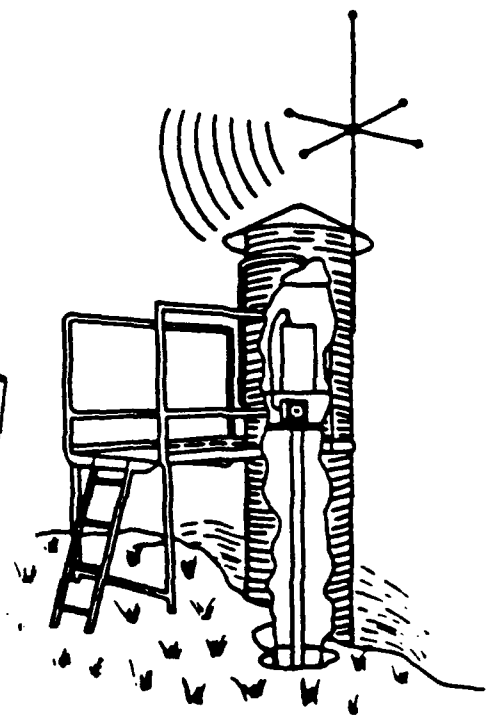
FIGURE I-2

Base Station

Remote Site Stream Gauge

FLOOD WARNING HARDWARE - SANTA CRUZ

7. Flood Warning System. In 1983, the Rio Piray flooded the city of Santa Cruz with peak discharges that were four to six times larger than the 100-year flood. This was caused by landslides and damming effects in the upper watershed. The flood killed over 800 people. This could have been avoided with a flood-warning system. To prevent this type of disaster in the future, we recommend that a state-of-the-art flood-warning system be installed in Santa Cruz. Details on the flood warning system are contained in Appendix I. The cost of such a system is about \$300,000.

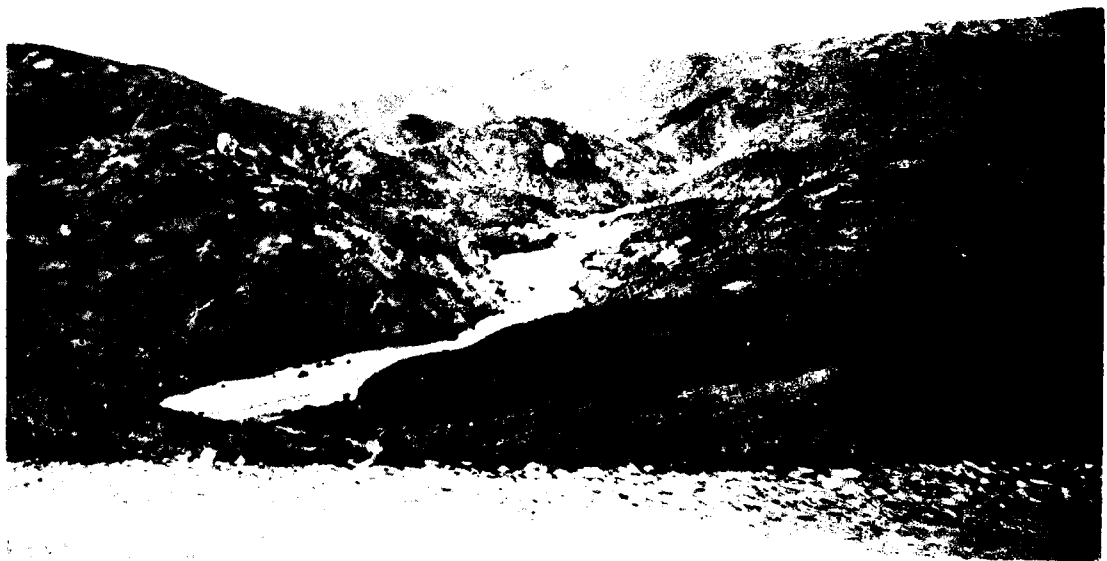
Photo 2. Typical Wadi Dam Site in Alluvial Valley

14. Construction of Wadi Dams. In the departments of Cochabamba, Chuquisaca and Potosi, there is a substantial amount of seasonal runoff that infiltrates into the ground and flows down the valley gradient as groundwater. The construction of a subsurface dam, called a Wadi dam, will store the water for use during the dry season. A design for Wadi dams is shown in Appendix L. These dams can be built mostly with hand labor. If a source of clay, bentonite, has to be trucked in, there would be an additional cost of \$2,000 to \$6,000. We recommend that the camposinos be given technical assistance in the siting and construction of Wadi dams. The cost of this program will vary according to the number of sites evaluated and the amount of materials needed, but should be less than \$100,000.

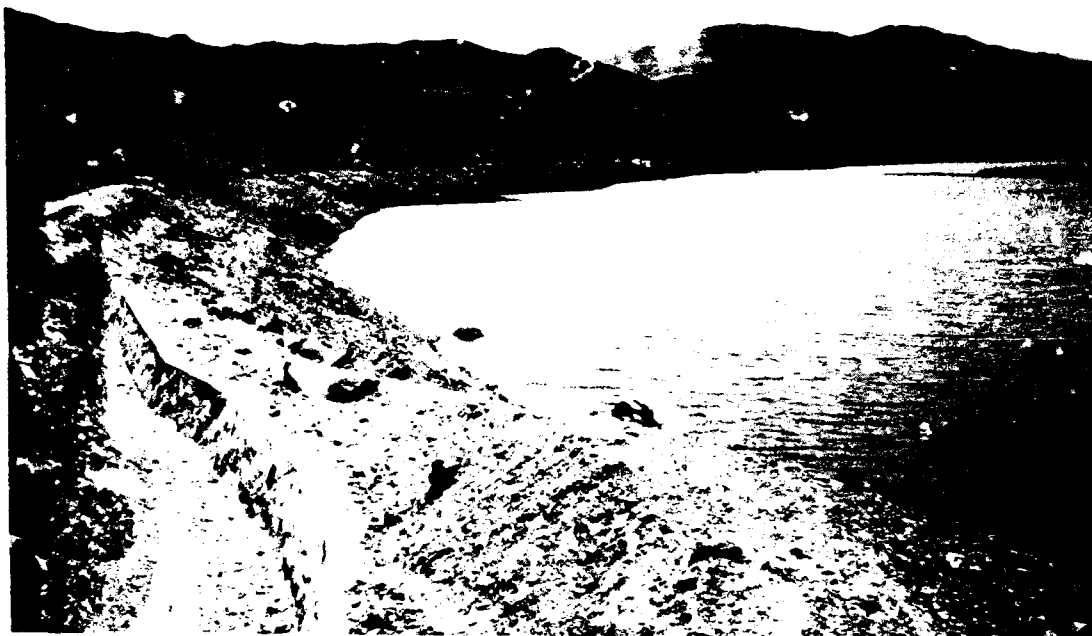
Photo 5. Punata Tiraque Irrigation Project Showing a Lake and Distribution Channel

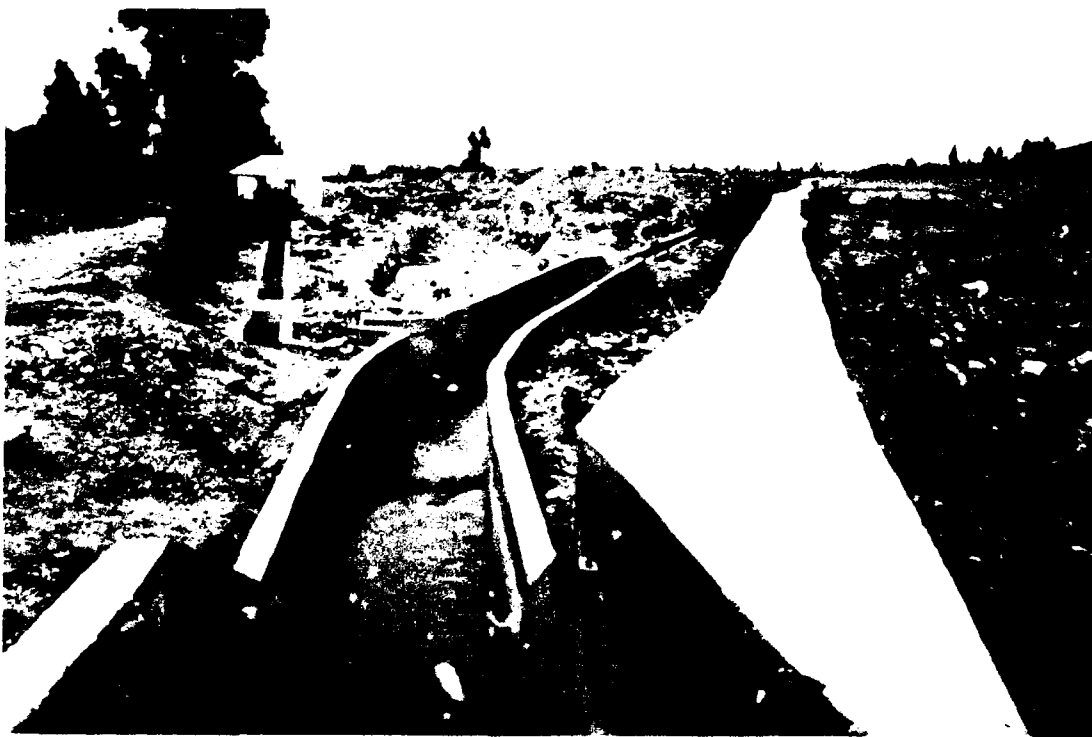
Photo 6. Punata Tiraque Irrigation Project Showing Irrigation System Channels

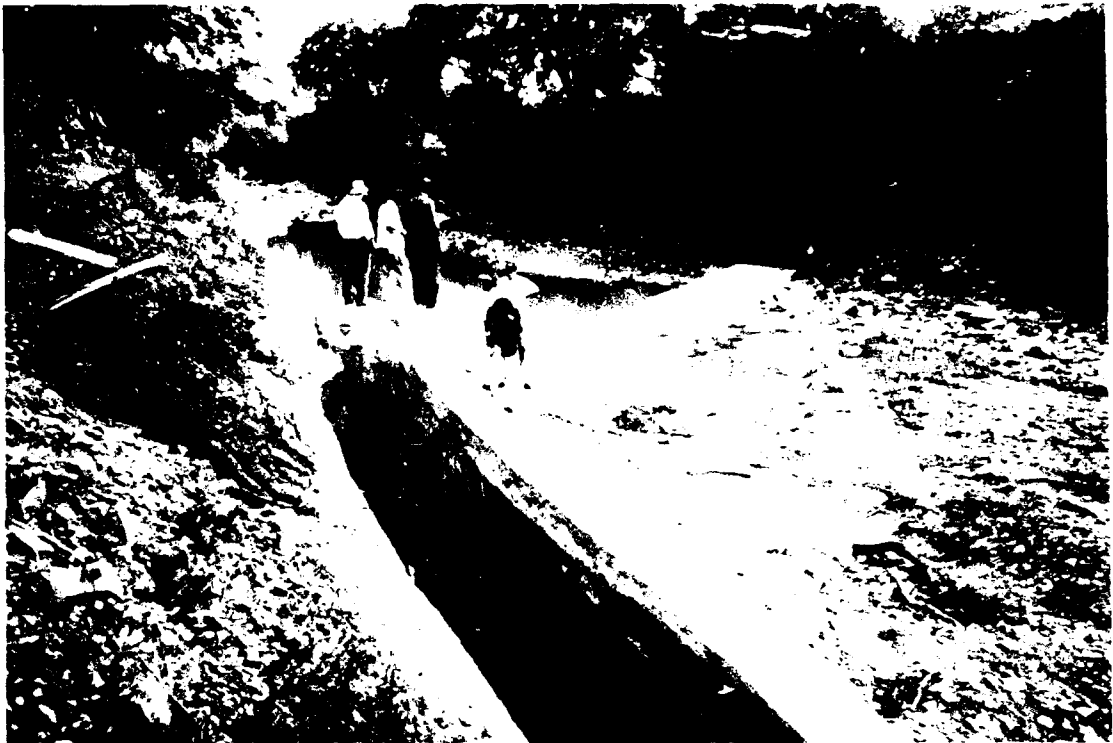
Photo 7. Flow Diversion Structure for Irrigation of Farms
Near Aiquile

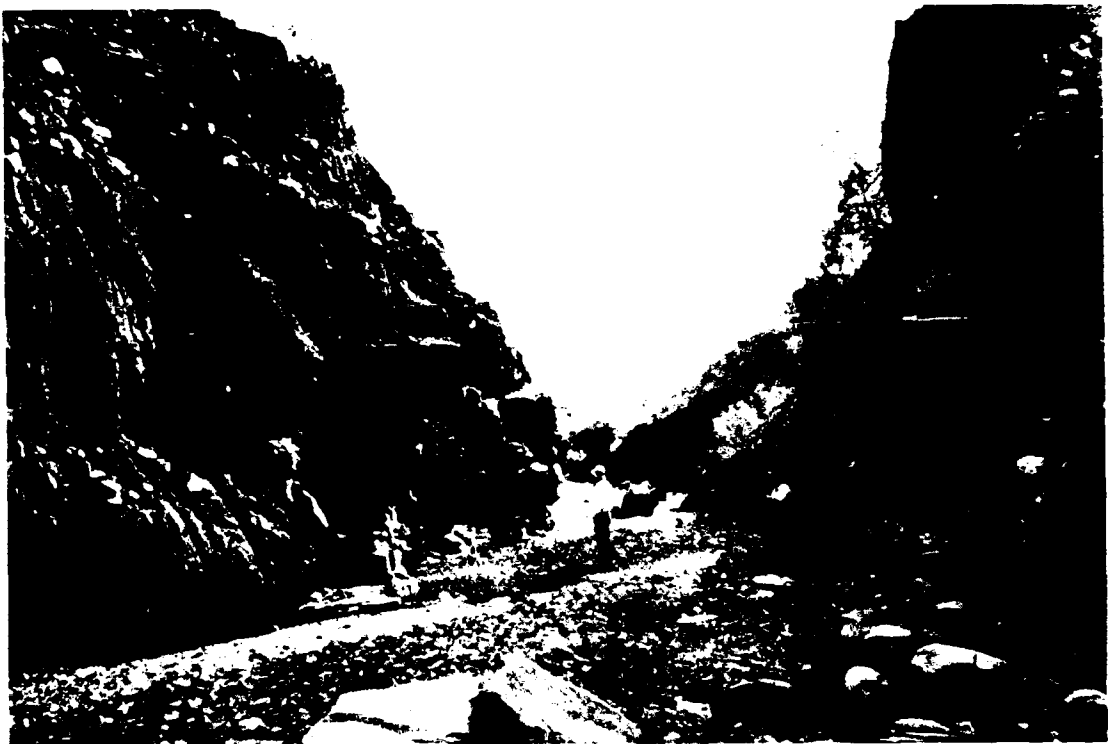
Photo 8. El Salto Dam Failure - Note Rock Outcrops in Earth Fill

This \$1.5 million project will irrigate between 300 and 500 hectares. A second site about three kilometers upstream of the failed El Salto site should be further investigated for development. The feasibility of dams at these sites could be developed for a cost of about \$75,000. Details on these dam sites are contained in Appendix A.

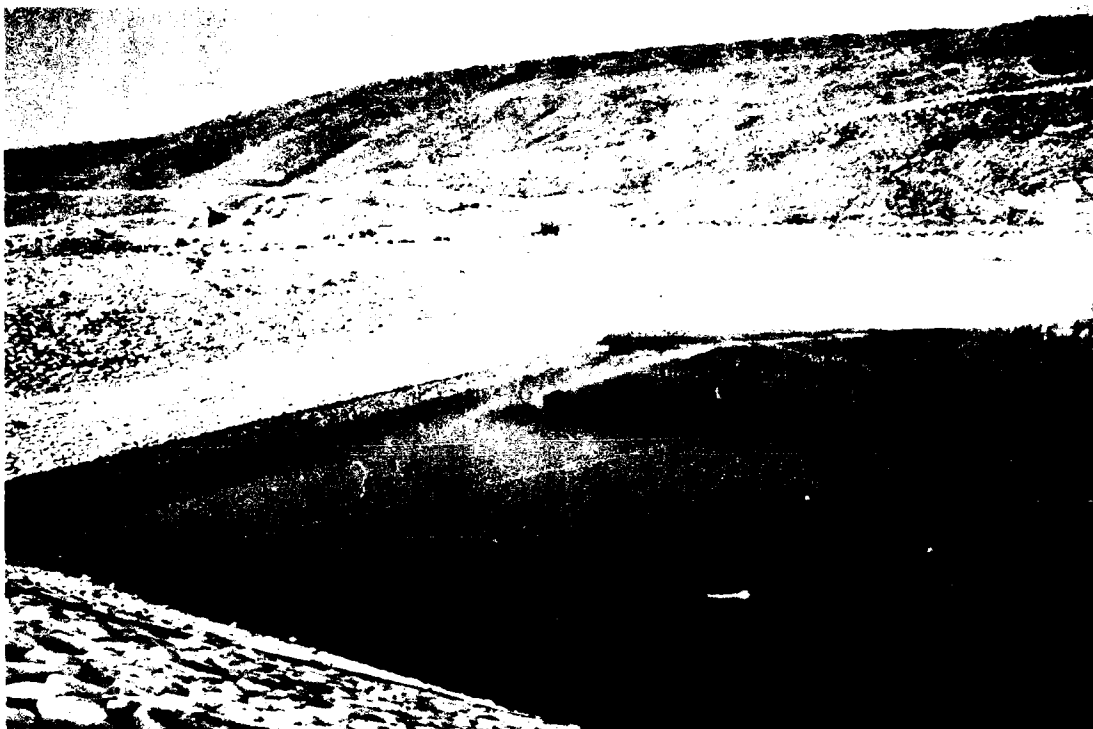
Photo 9. Nearly Empty Water Supply Dam Above City of Potosi -
Elev. 4,500 meters

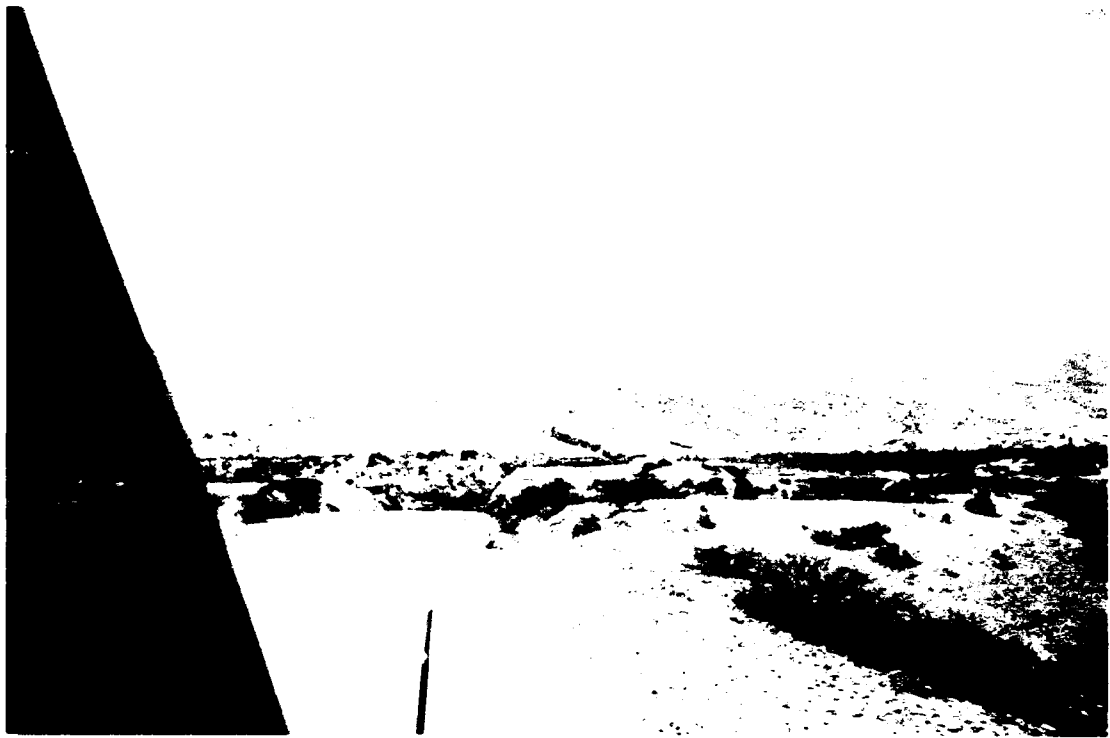
Photo 11. Tarija Valley - Note Failure of Natural Dam at Scar on Hillside

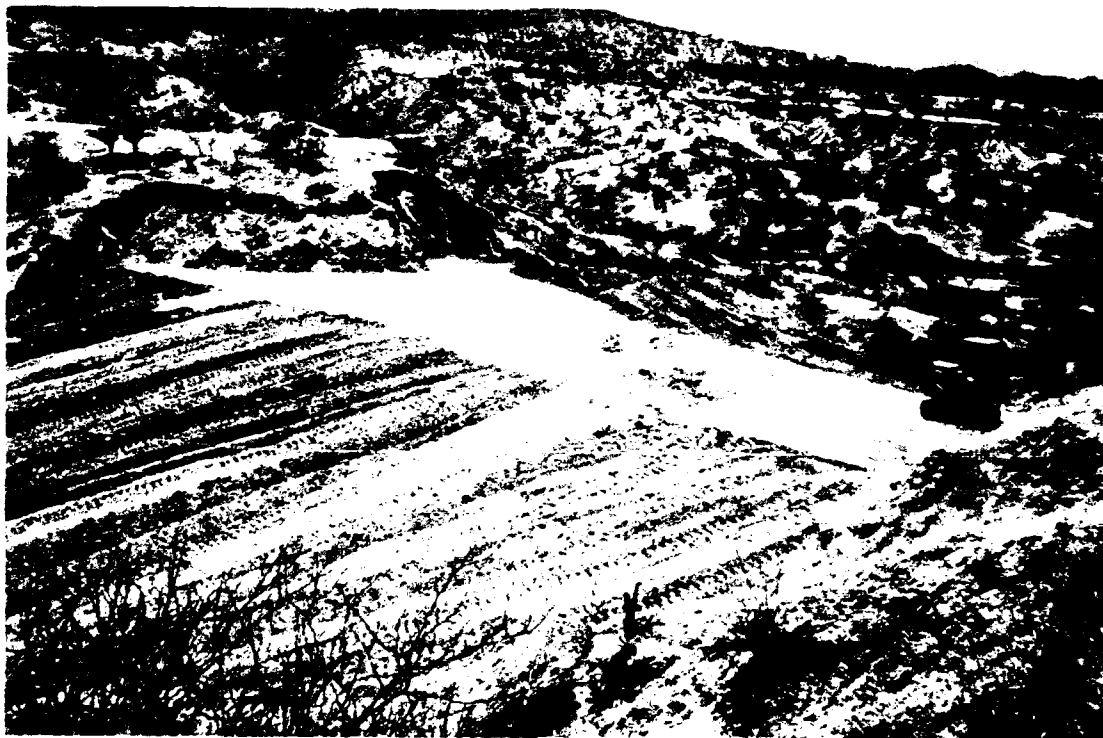
Photo 14. Watershed Erosion Control Dam Under Construction Near City of Tarija

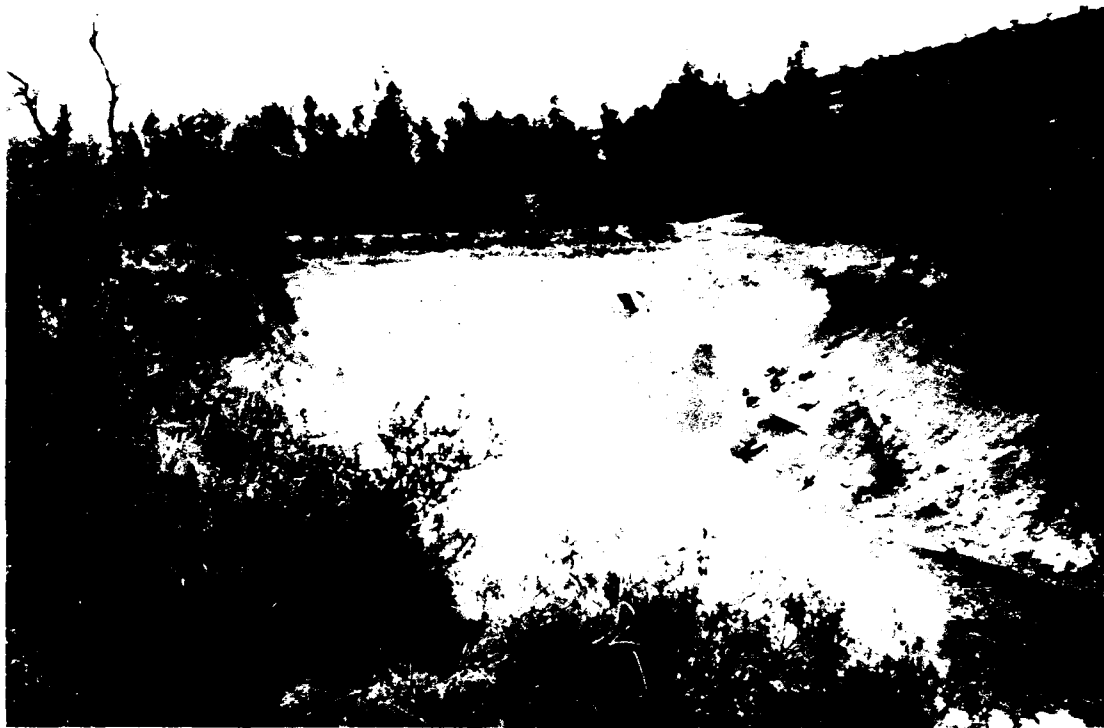
Photo 15. Erosion Control Dam Being Filled - Note Flow Entering from Right Tarija

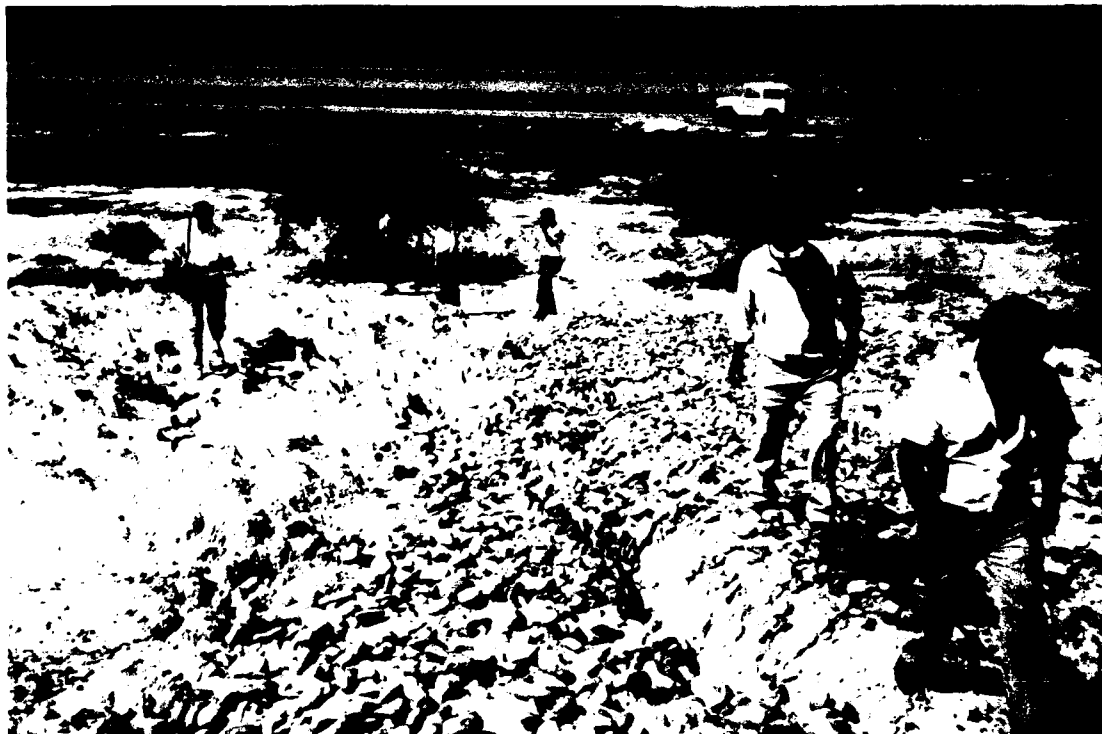
Photo 16. Tarija Airport Erosion - Flow is Toward Runway in Background

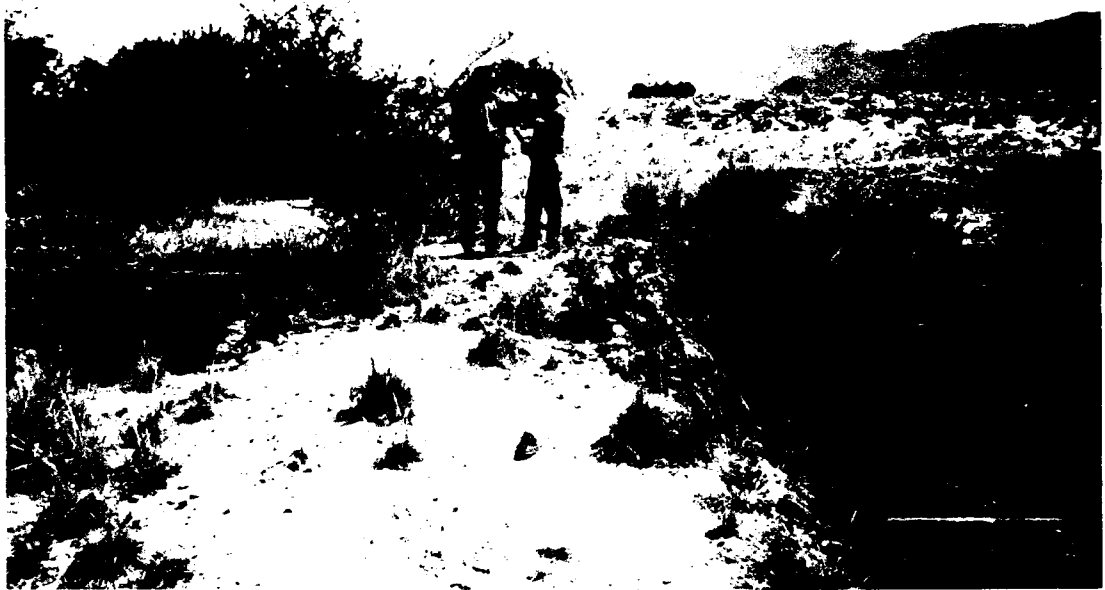
Photo 17. Tarija Airport - Erosion Caverns Downstream from the Runway in Background

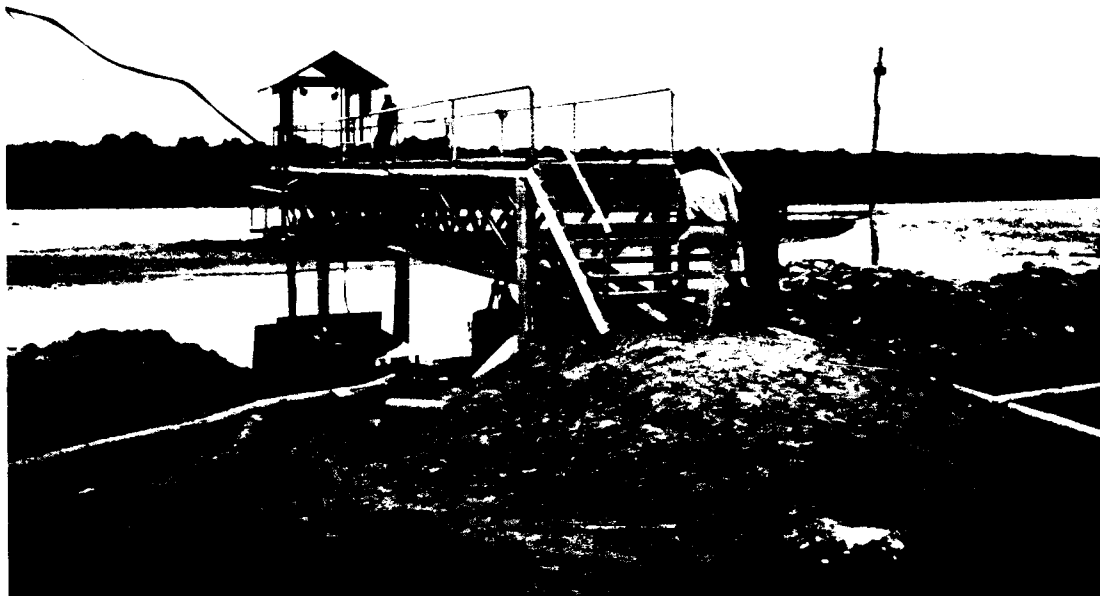
Photo 21. Water Intake Esquema Irrigation Project - Rio Pilcomayo Near Villa Montes

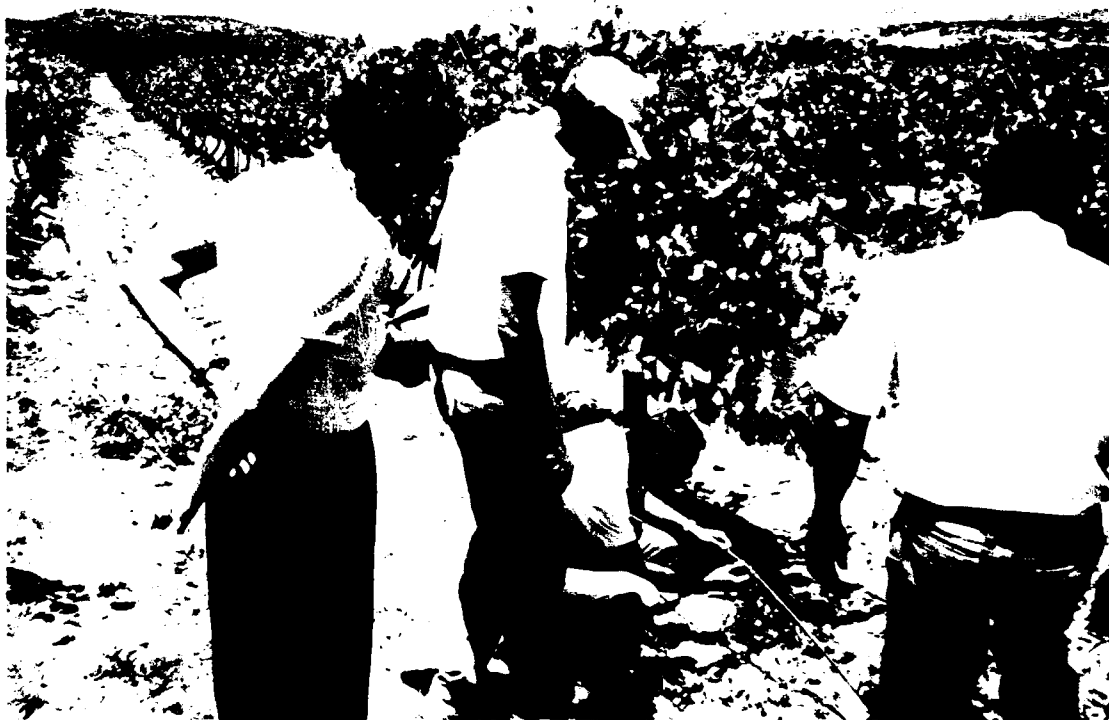
Photo 22. Drip Irrigation of Vineyards in San Juan Valley Near City of Tarija

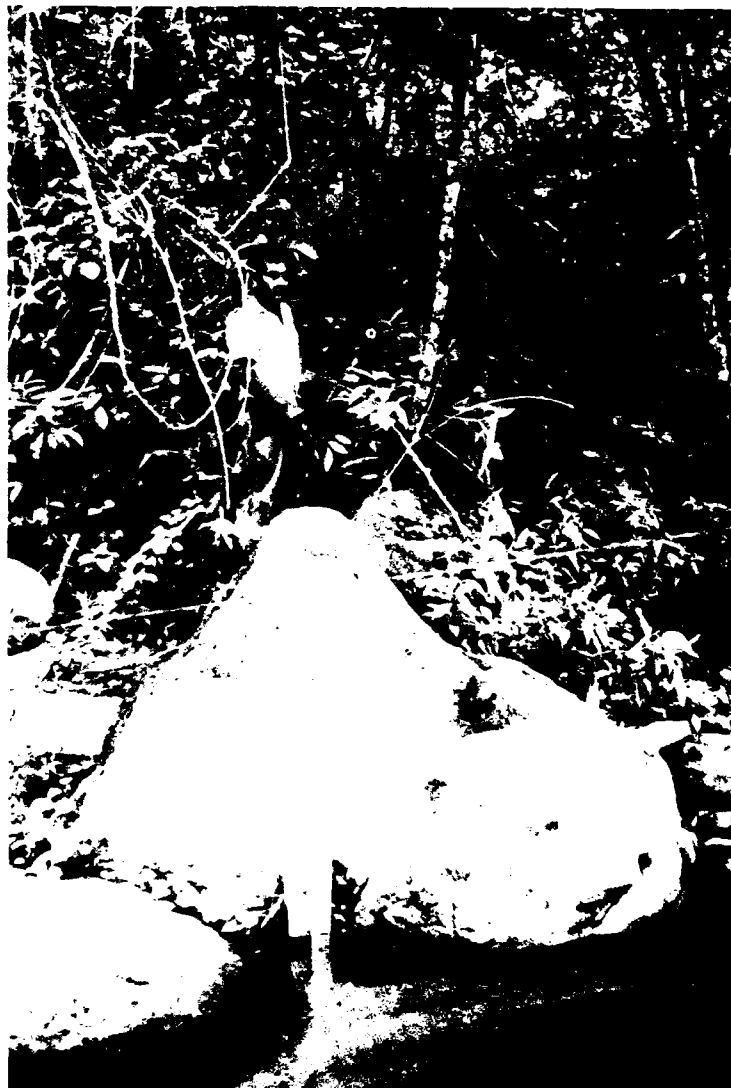
Photo 23. Stream Gage Near Location of Aguayrenda Dam -
Department of Tarija

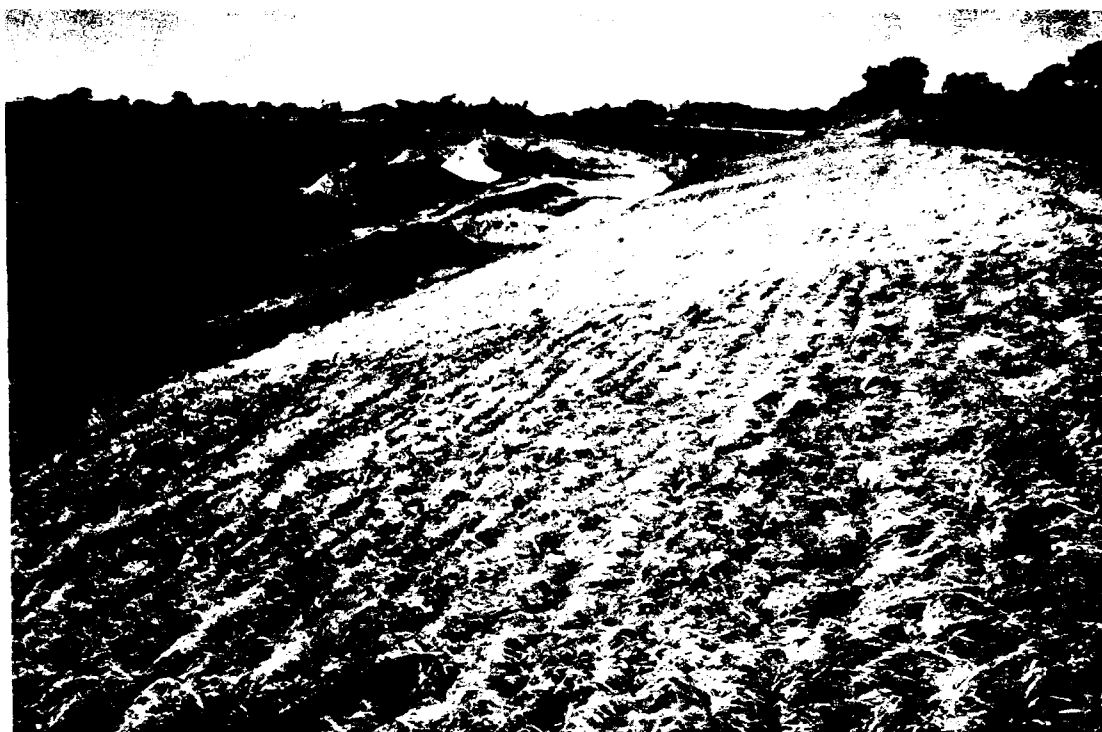
Photo 24. Flood Control Levee Under Construction on Rio Piray -
City of Santa Cruz

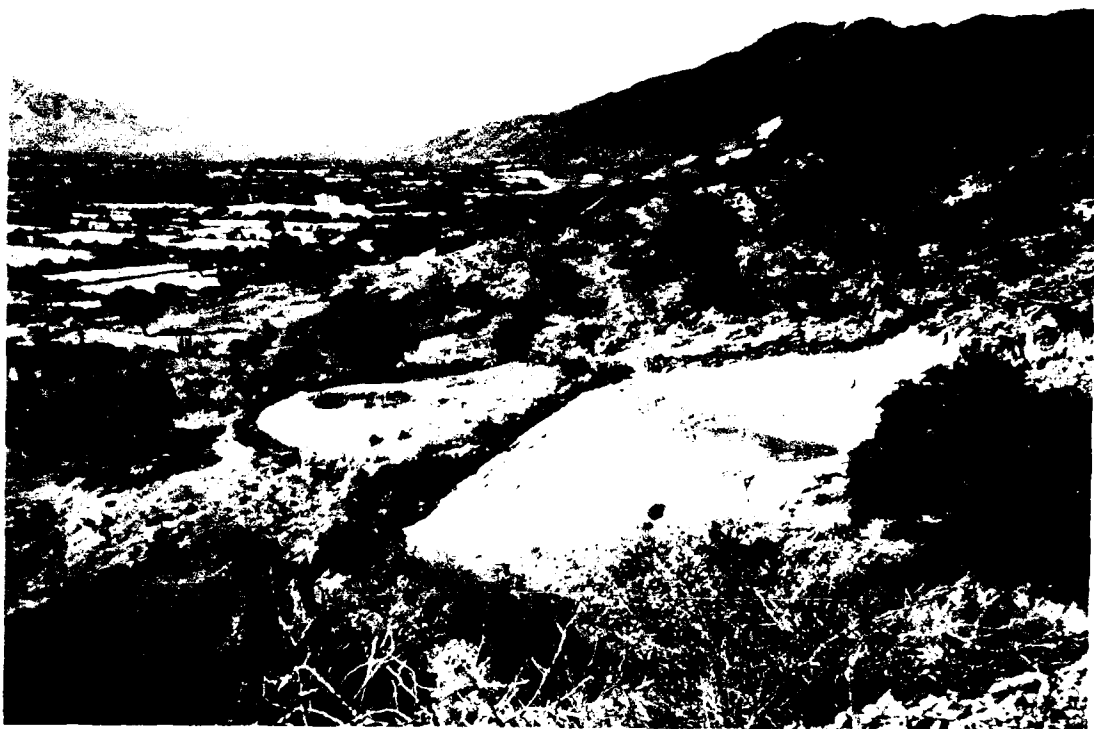
Photo 26. Water Holding Ponds Near Vallegrande - Department of Santa Cruz

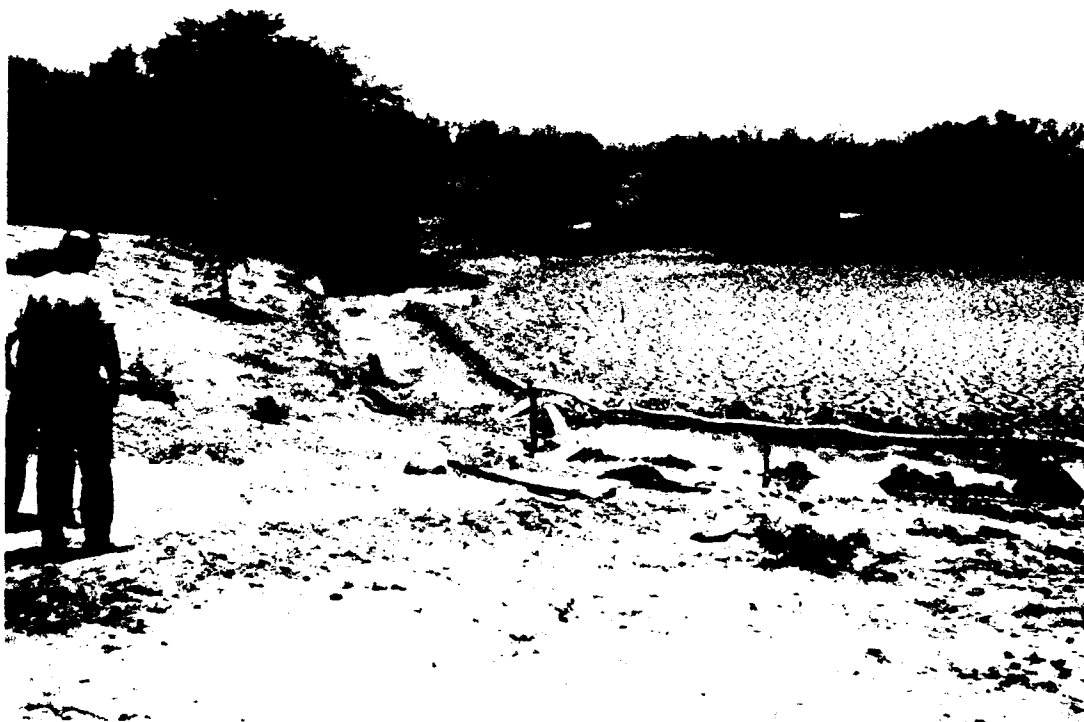
Photo 27. Typical Watering Cistern in Chaco - Water Shared by Humans and Livestock

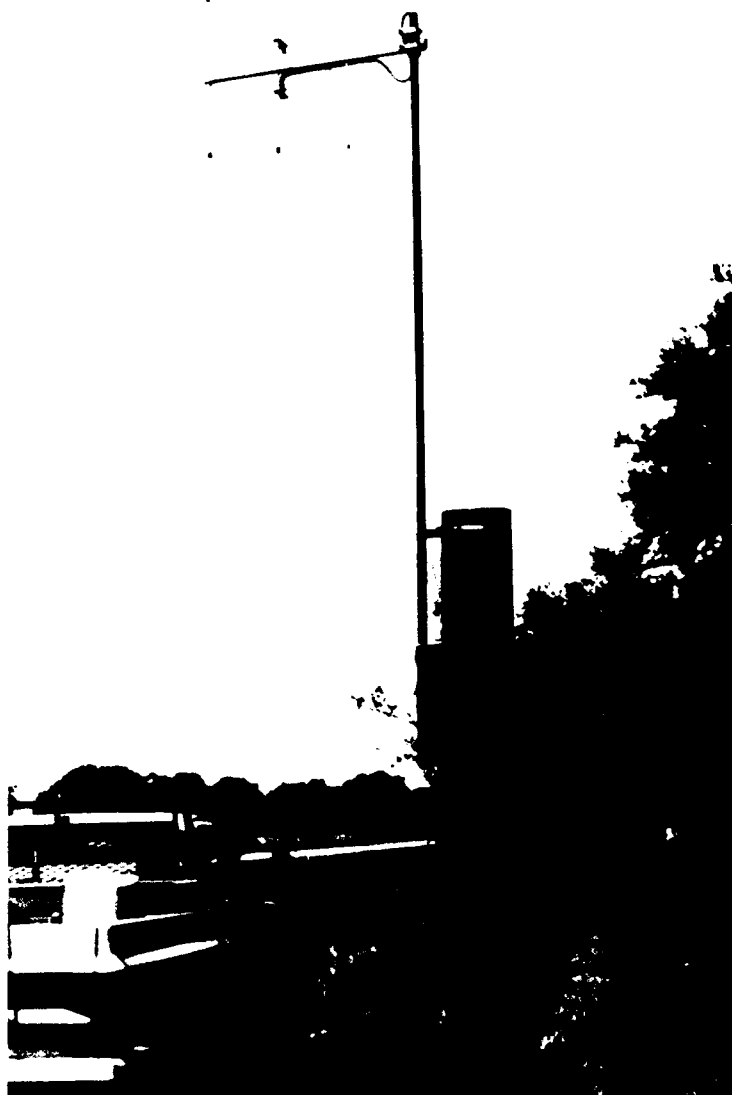
Photo 32. Automatic Radio Reporting Station - Rain and Stream Flow Data

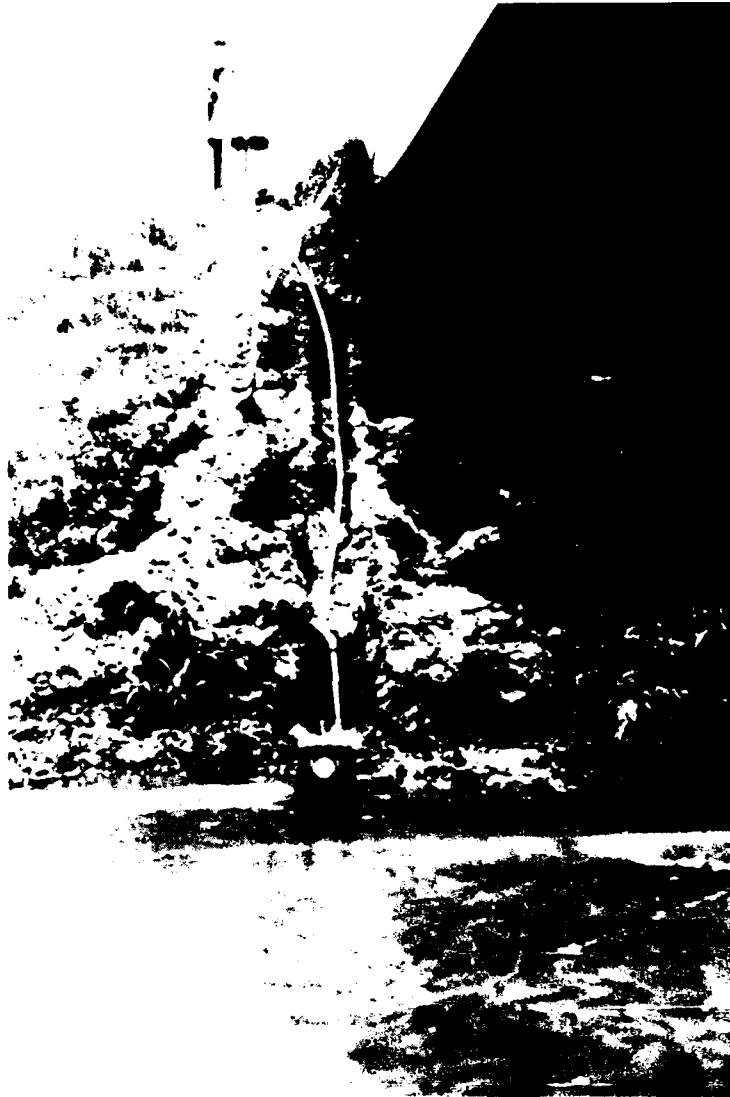
Photo 33. Pressure Transducer to Measure Water Level - Radio Reporter in Background

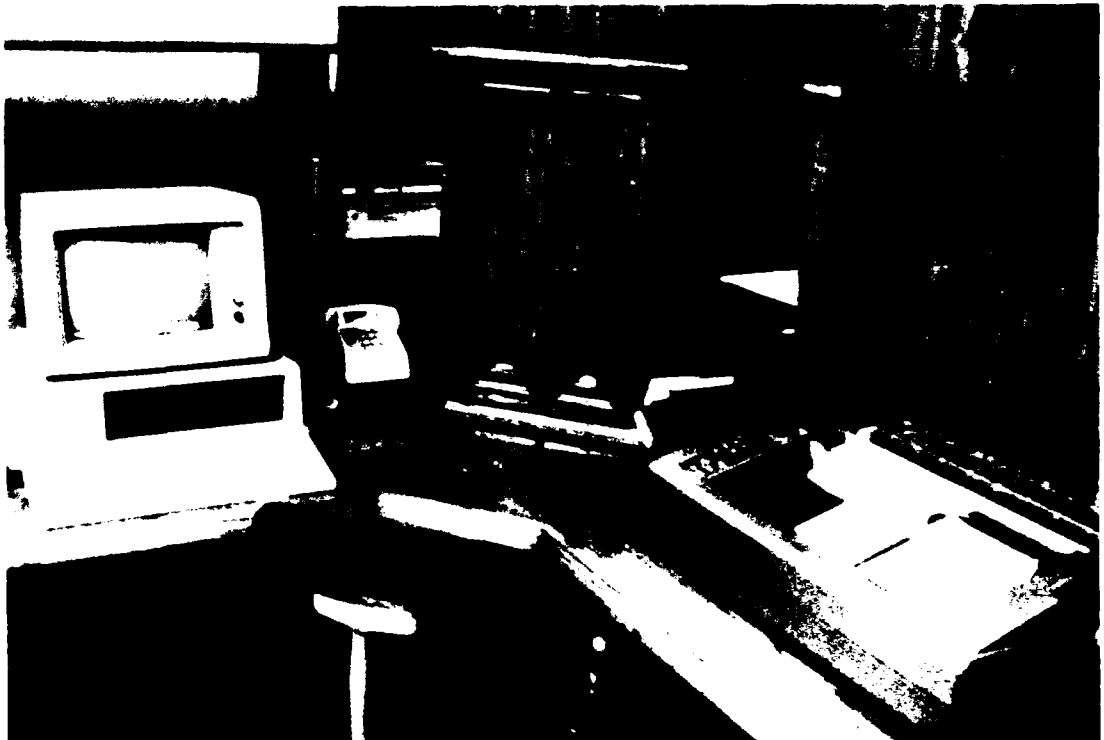
Photo 35. Base Station Control Center for Data Collection and Flood Warning
